U.S.-Canada Power System Outage Task Force

Interim Report:  
Causes of the  
August 14th Blackout  
in the  
United States and Canada

November 2003

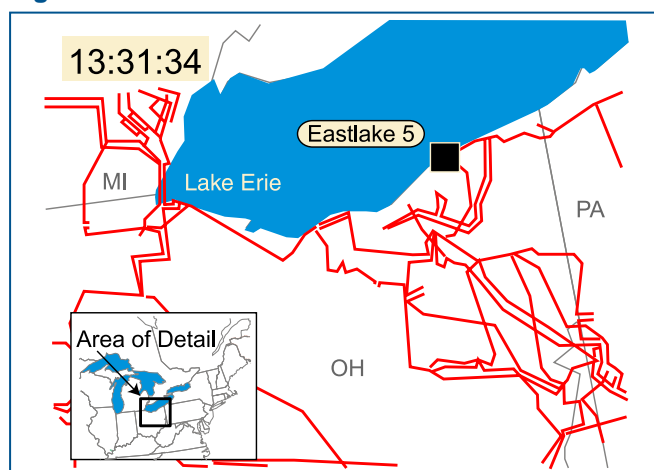
**Figure 4.3. Eastlake Unit 5**

system was consuming so much reactive power that it was a net importer, bringing in about 132 MVar.

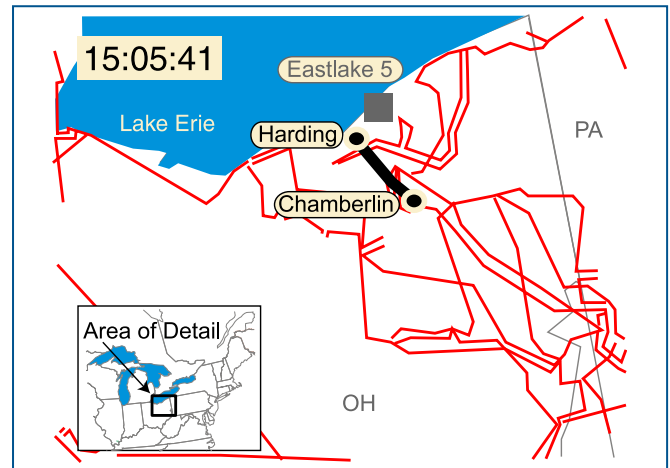
Figure 4.8. Harding-Chamberlin 345-kV Line

line's status change, this was presented to MISO operators as breaker status changes rather than a line failure. Because their EMS system topology processor had not yet been linked to recognize line failures, it did not connect the breaker information to the loss of a transmission line. Thus, MISO's operators did not recognize the Harding-Chamberlin trip as a significant contingency event and could not advise FE regarding the event or its consequences. Further, without its state estimator and associated contingency analyses, MISO was unable to identify potential overloads that would occur due to various line or equipment outages. Accordingly, when the Harding-Chamberlin 345-kV line tripped at 15:05 EDT, the state estimator did not produce results and could not predict an overload if the Hanna-Juniper 345-kV line were to fail.<sup>25</sup>

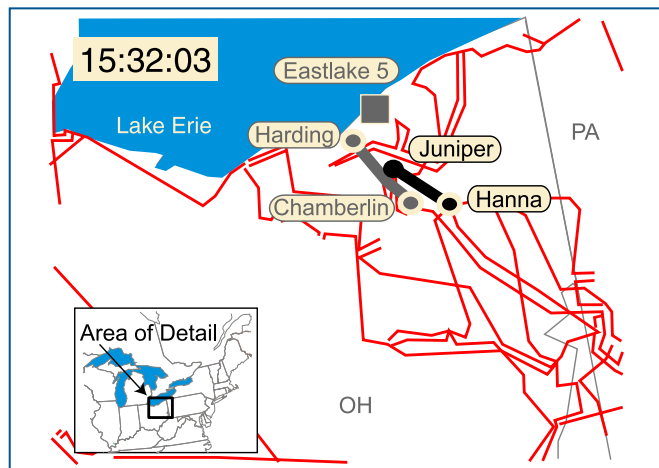
**Figure 4.9. Hanna-Juniper 345-kV Line**

Hanna-Juniper was loaded at 87.5% of its normal and emergency rating when it tripped. With this line open, almost 1,000 MVA had to find a new path to reach its load in Cleveland. Loading on the remaining two 345-kV lines increased, with Star-Juniper taking the bulk of the power. This caused Star-South Canton's loading to rise above its normal but within its emergency rating and pushed more power onto the 138-kV system. Flows west into Michigan decreased slightly and voltages declined somewhat in the Cleveland area.

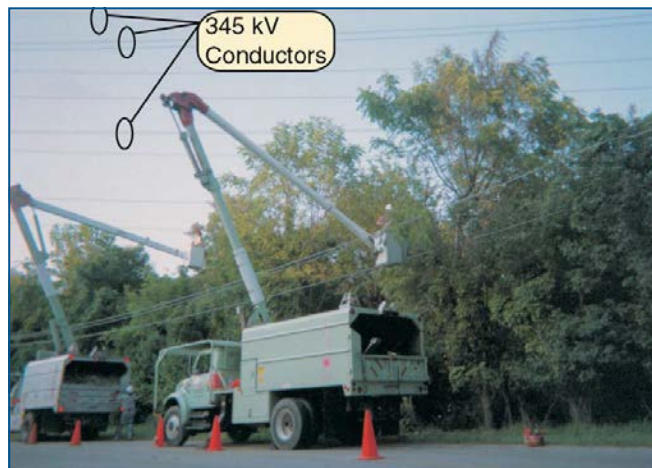
**Figure 4.10. Cause of the Hanna-Juniper Line Loss**

This August 14 photo shows the tree that caused the loss of the Hanna-Juniper line (tallest tree in photo). Other 345-kV conductors and shield wires can be seen in the background. Photo by Nelson Tree.
